## Clinical conduct for restoration of non-carious cervical lesions – Case Report

This case was realized at UFF (Universidade Federal Fluminense) with the following Team:

Juni 2019

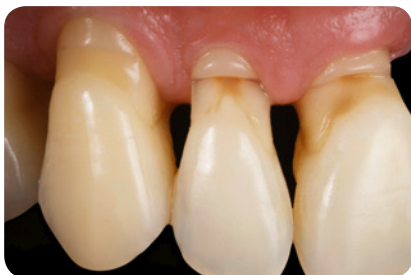
Image 1: Initial appearance of NCCL (frontal view)

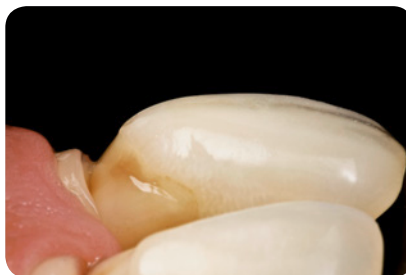
Image 2: Initial appearance of NCCL (proximal view)

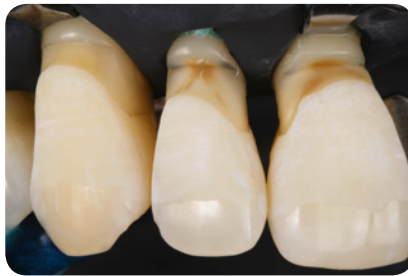
Image 11: Appearance of the enamel after acid etching

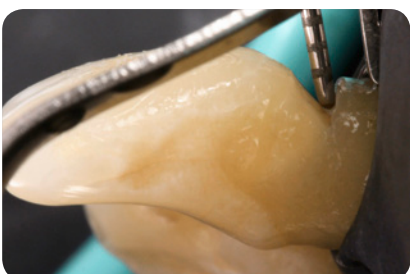
Image 16: Measuring the depth of the lesion. Lesions up to 2 mm deep can be restored with a single increment.

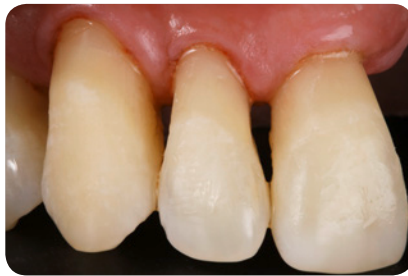
Image 23: Appearance after removal of absolute isolation

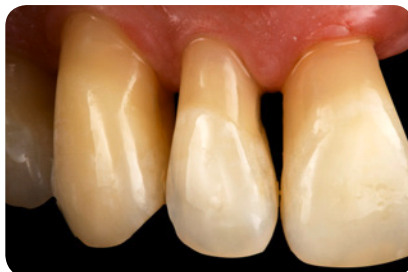
Image 29: End Result
